**PRE-DEMOLITION/DISPOSAL ASBESTOS SURVEY REPORT
AT THE
FORMER BAYONNE BARREL & DRUM PROPERTY
150-154 Raymond Boulevard
Newark (Essex County), New Jersey**

**CODE Enviro-Sciences, LLC.
400 Middlesex Avenue
Carteret, New Jersey 07008
Project No. 251248**

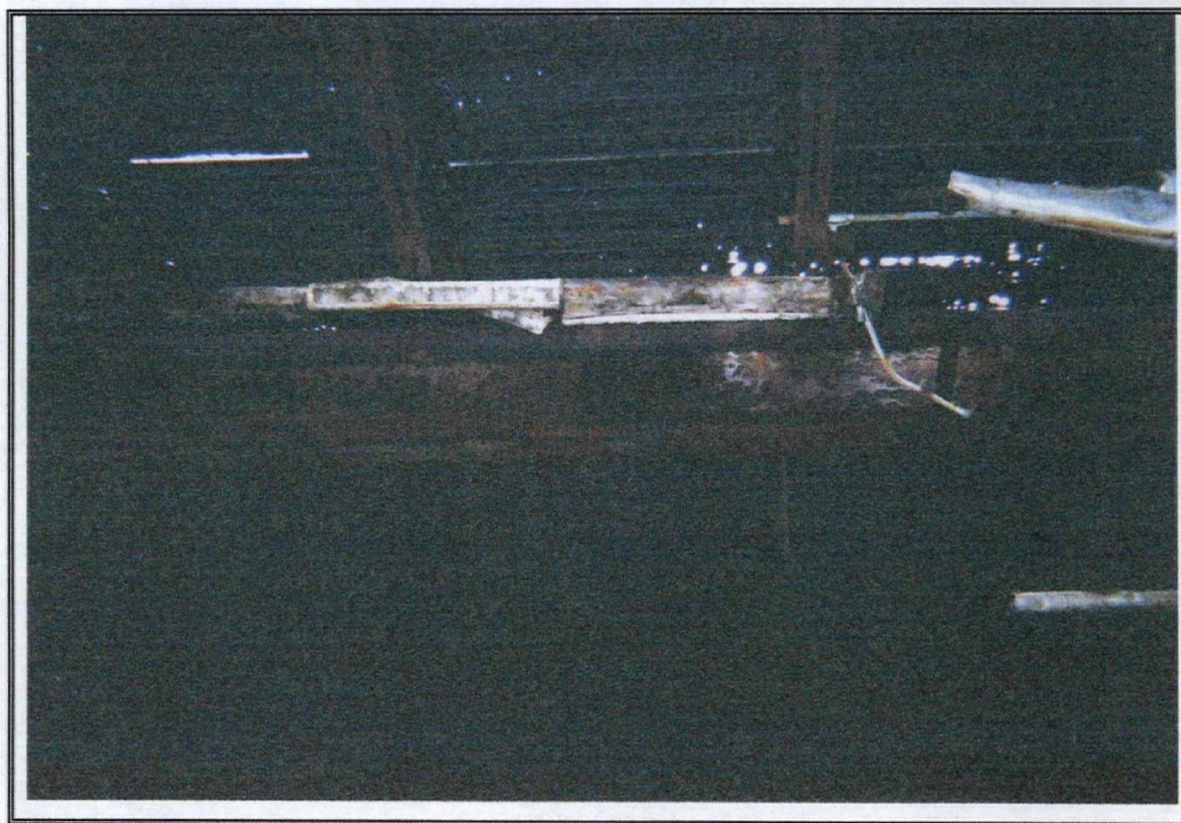
Photo No. 25

Building 1 pipe run. Samples 046-Bldg1 and 047-Bldg1 collected from pipe insulation. The pipe insulation was aluminum.

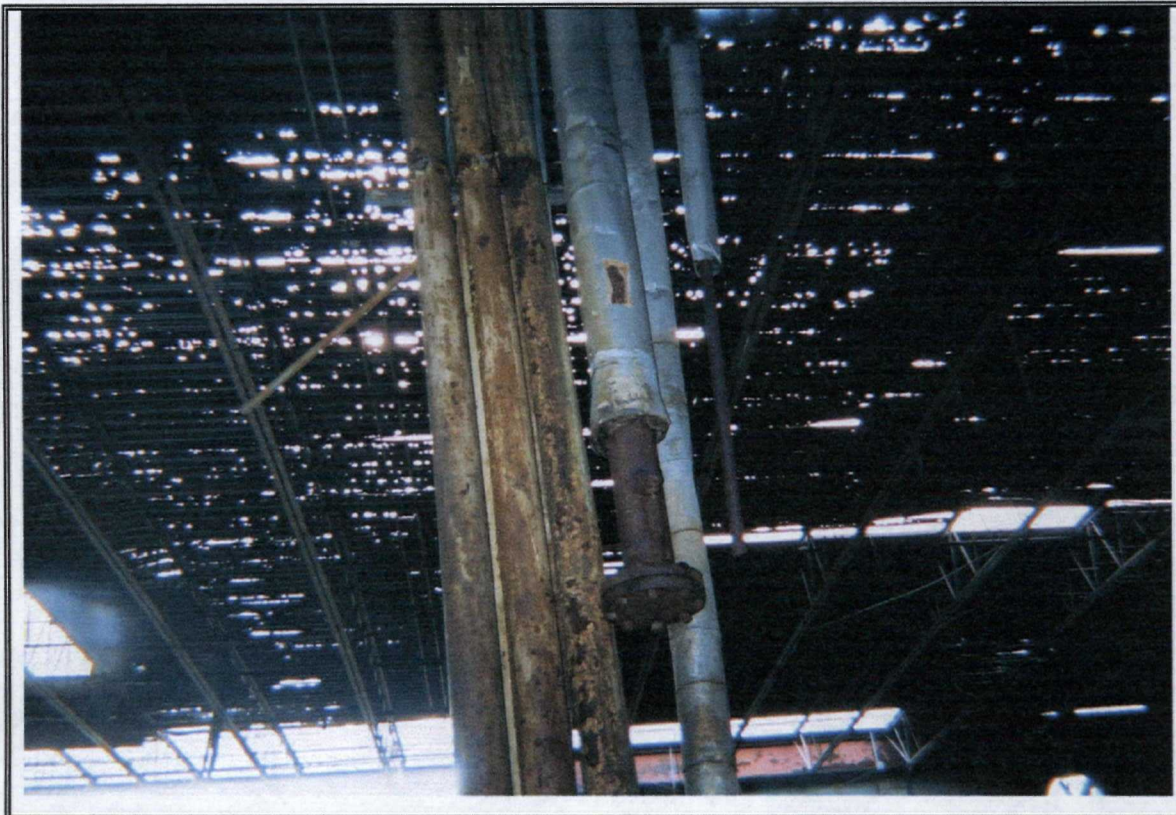
Photo No. 26

Building 1 pipe run along steel joist. Sample 047-Bldg1 was collected and analyzed from the pipe insulation. The pipe wrap was aluminum.

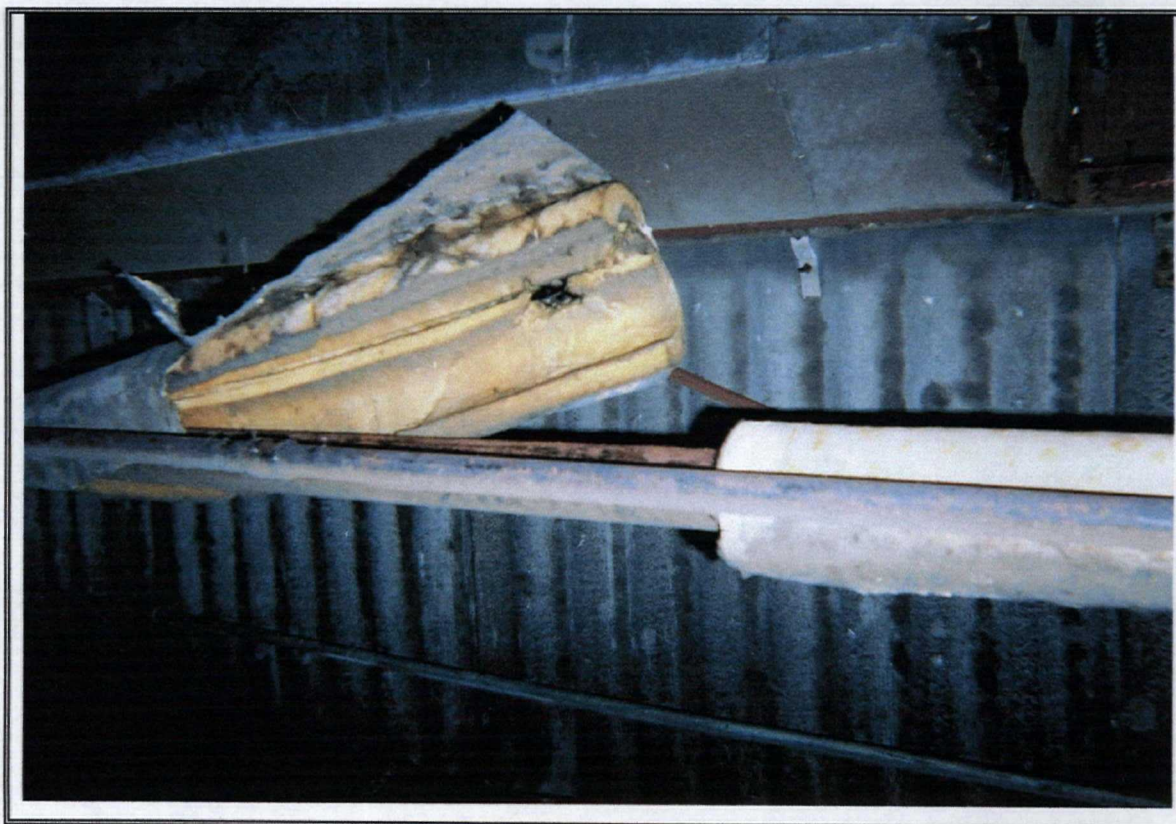
Photo No. 27

Building 4 pipe run (front building). Sample 048-Bldg4 was collected from the pipe insulation and sample 049-Bldg4 was collected from the pipe wrap.

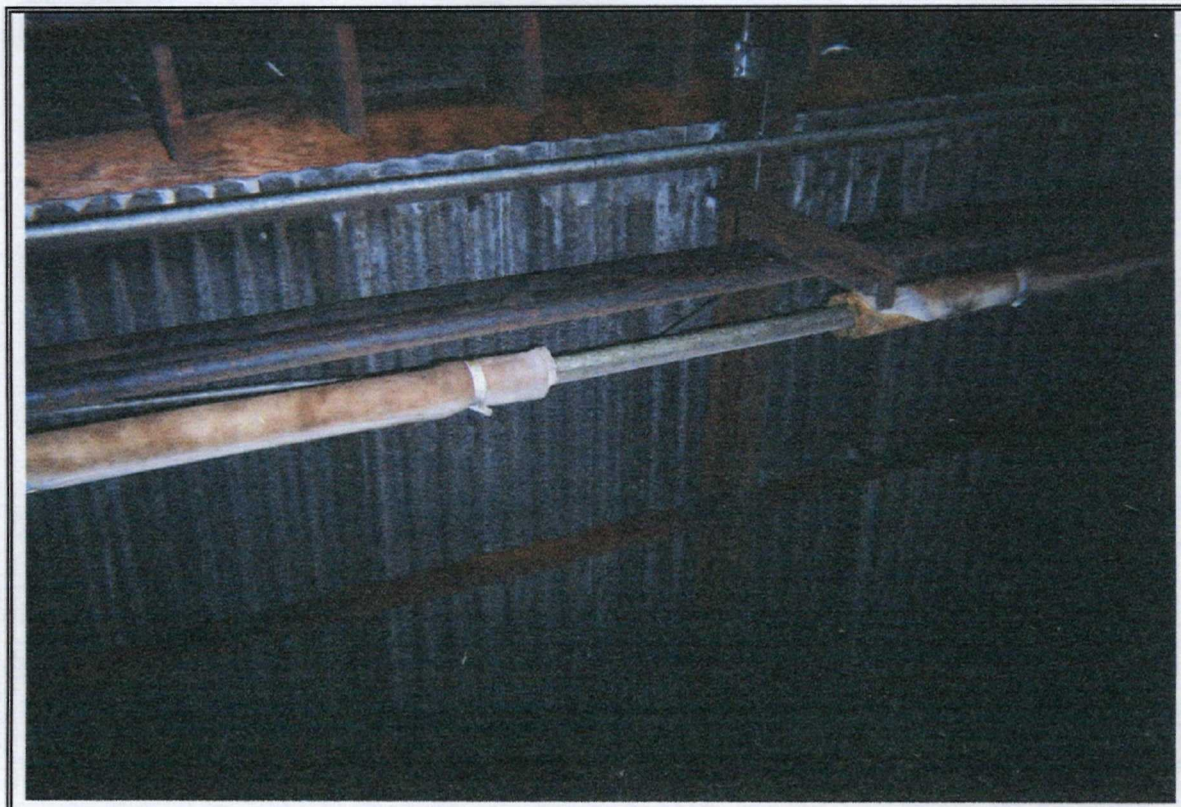
Photo No. 28

Building 4 pipe run (back of front building). Different pipe run than Photo 29. Sample 050-Bldg4 was collected from the pipe insulation and sample 051-Bldg4 was collected from the pipe wrap.

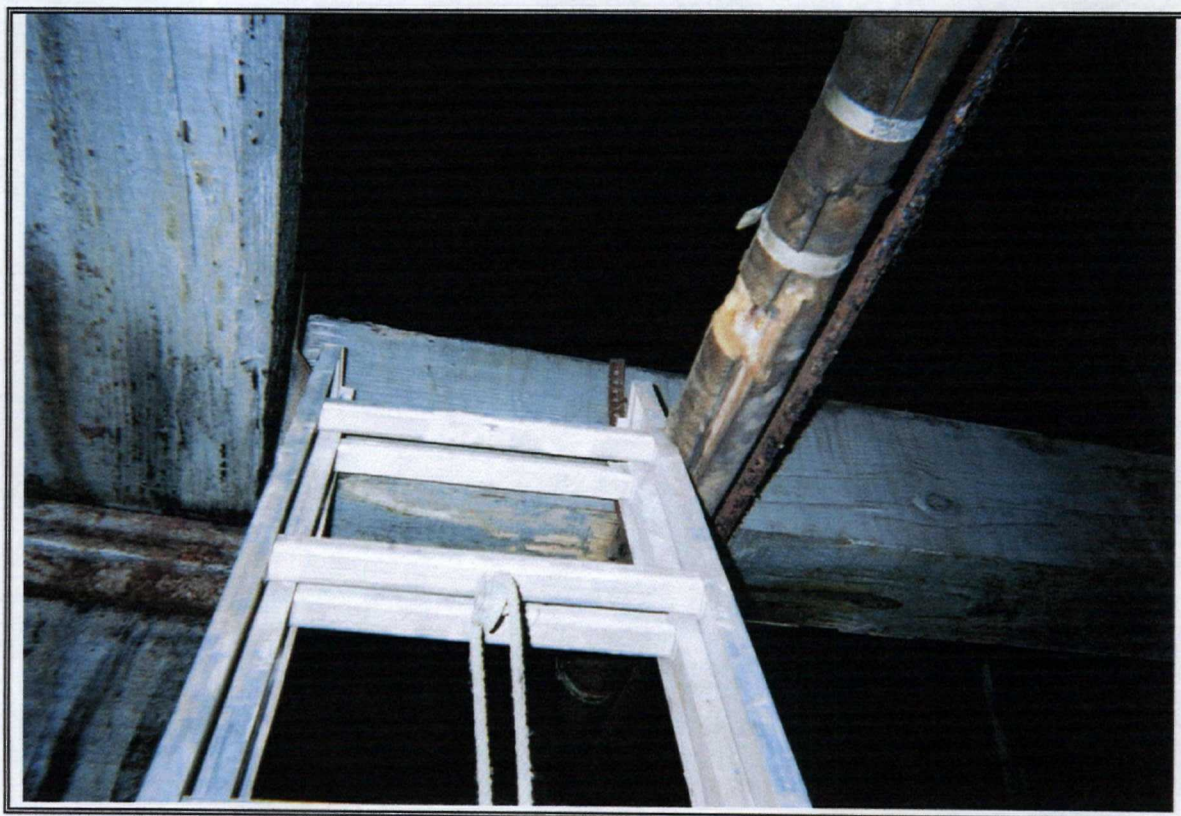
Photo No. 29

Building 4 (rear building) pipe run. Sample 052-Bldg4 was collected from the pipe insulation and sample 053-Bldg4 was collected from the pipe wrap.
